MERRIMACK RIVER BASIN
HARRISVILLE, NEW HAMPSHIRE

HARRISVILLE POND DAM
NH 00065

PHASE I INSPECTION REPORT
NATIONAL DAM INSPECTION PROGRAM

MAY 1979

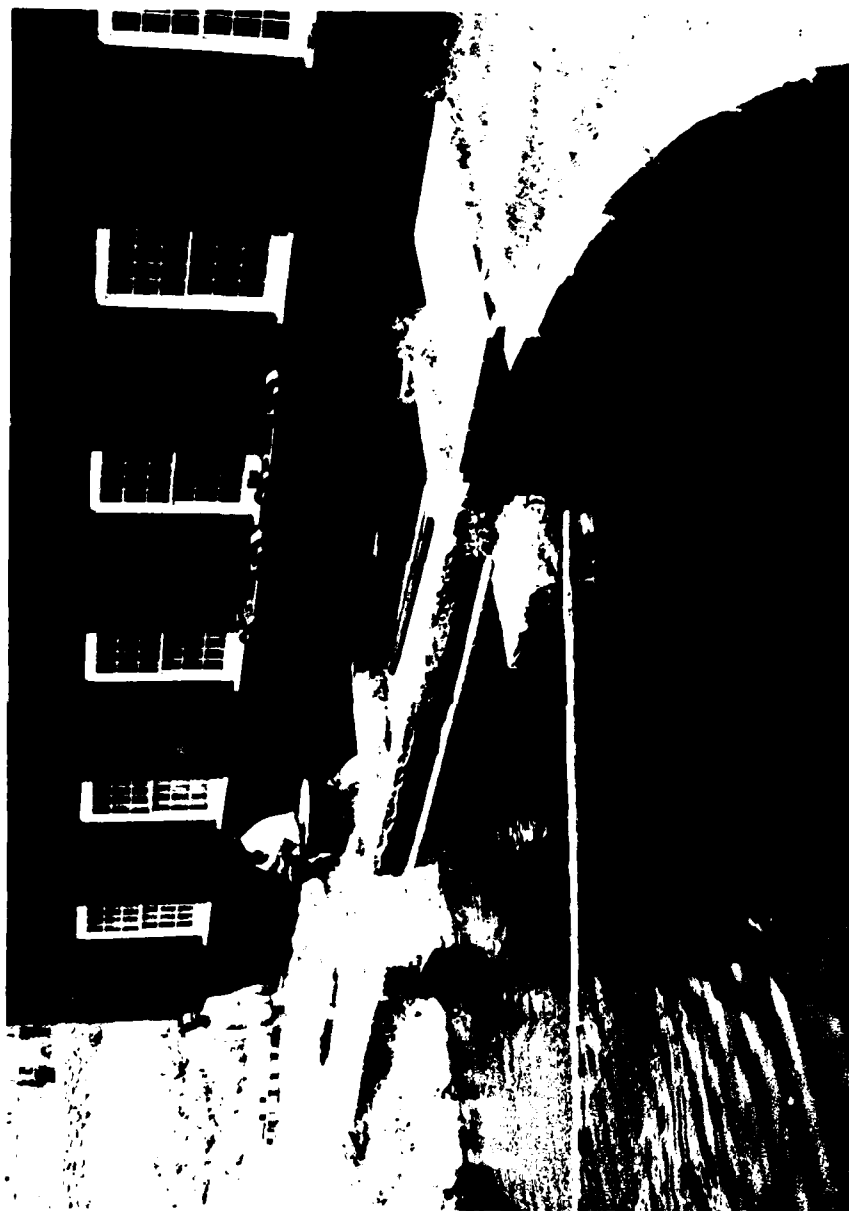
HARRISVILLE DAM, LOOKING SOUTHEAST
Negative No. 1-13

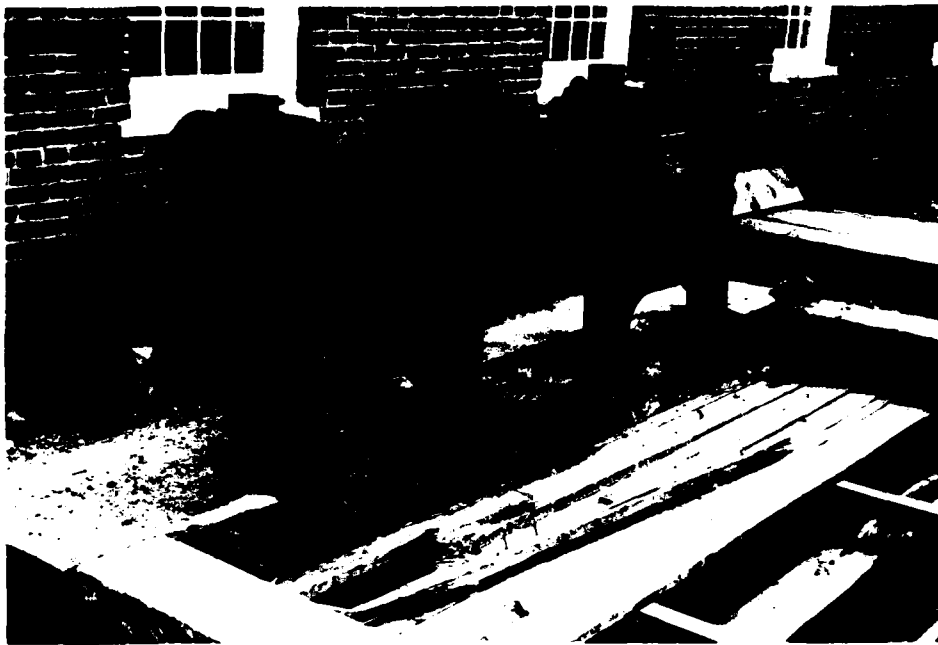
3. Rack-and-Pinion Gate Operators Over the Intake Structure.

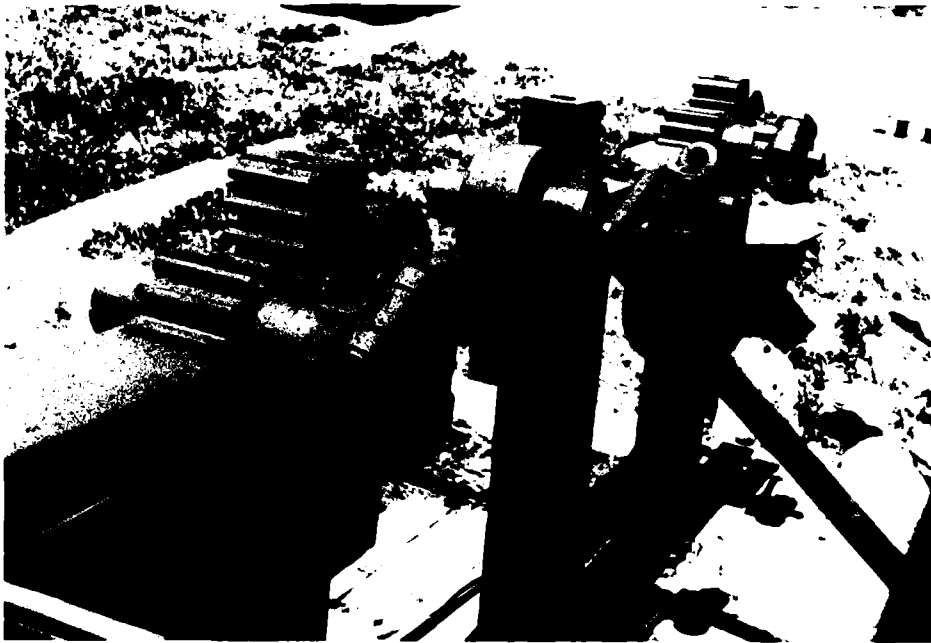
4. Detail of Rack-and-Pinion Gate Operators.

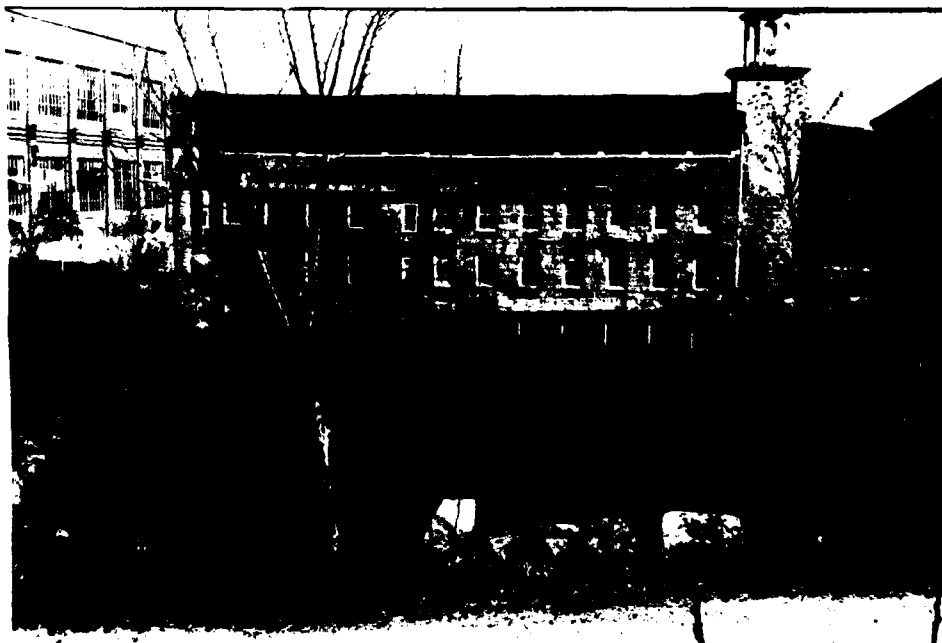
16. Lower Mill and Pond, Looking from the Road Below the Toy Shop.
